## PENTHOUSE TOWERS CONDOMINIUMS

### HIGHLAND BEACH MILESTONE STRUCTURAL INSPECTION REPORT

SEPTEMBER 11, 2023

**O&S Associates, Inc.**  
2500 Hollywood Blvd  
Suite 212  
Hollywood, FL 33020  
305.676.9888

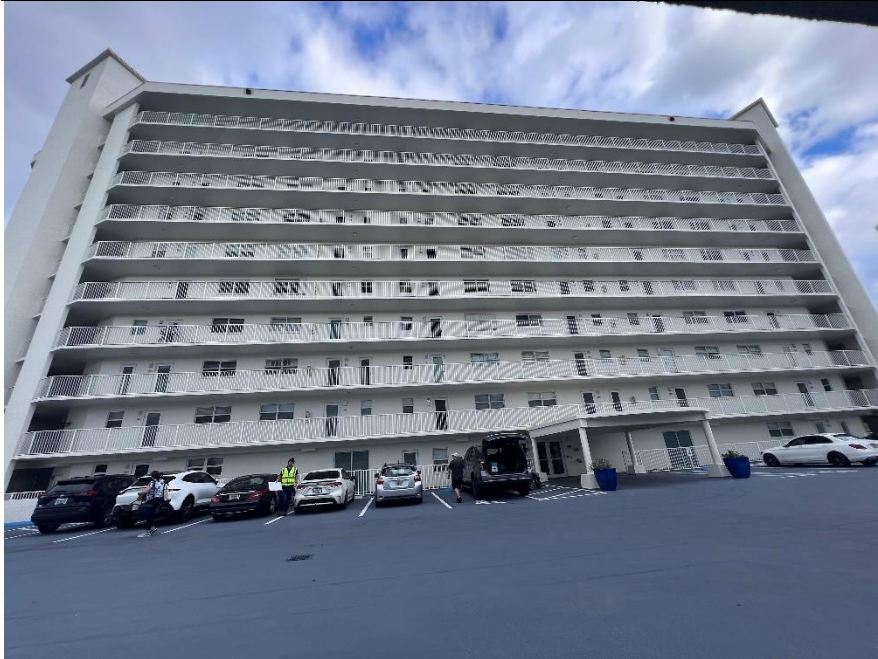
Photo #1:

Front Elevation of  
Penthouse Towers.

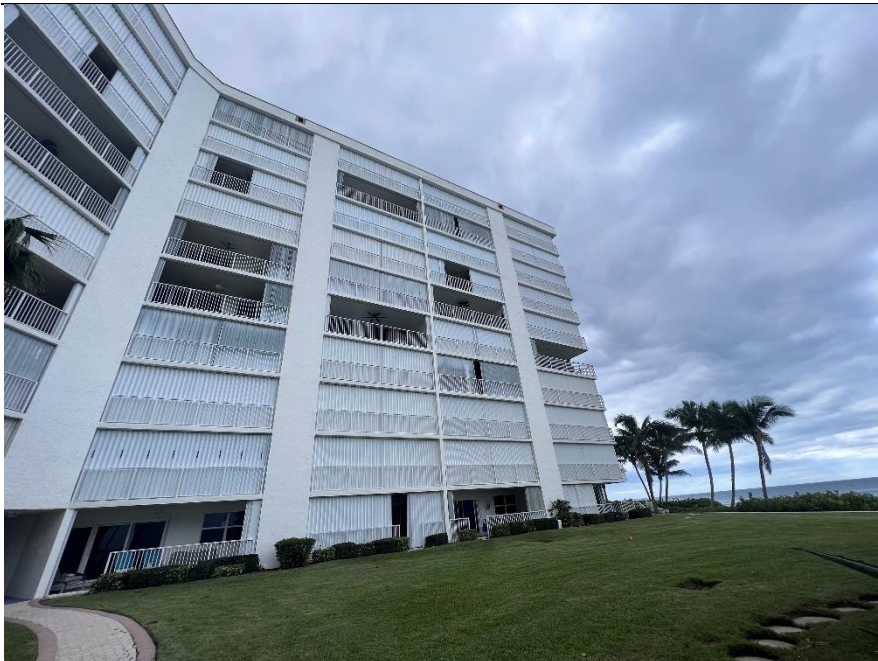
Photo #2:

East Elevation of Penthouse  
Towers

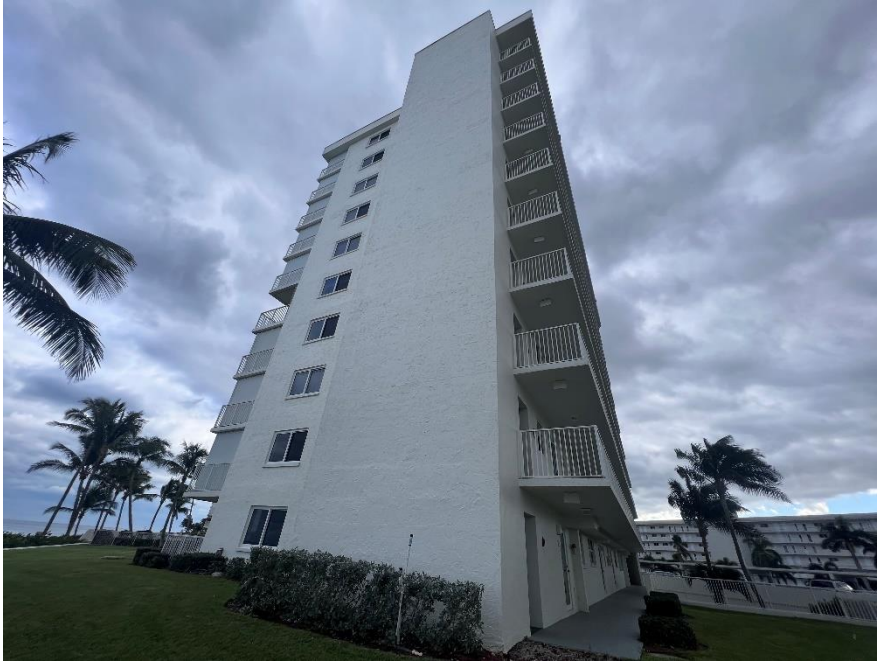
Photo #3:

South Elevation of  
Penthouse Towers.

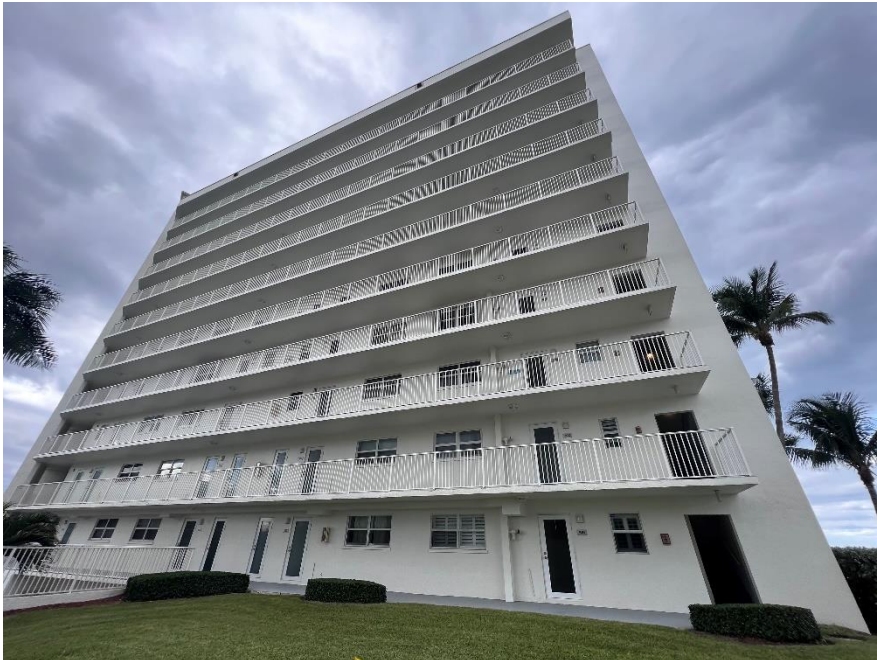
Photo #4:

North Elevation of  
Penthouse Towers.

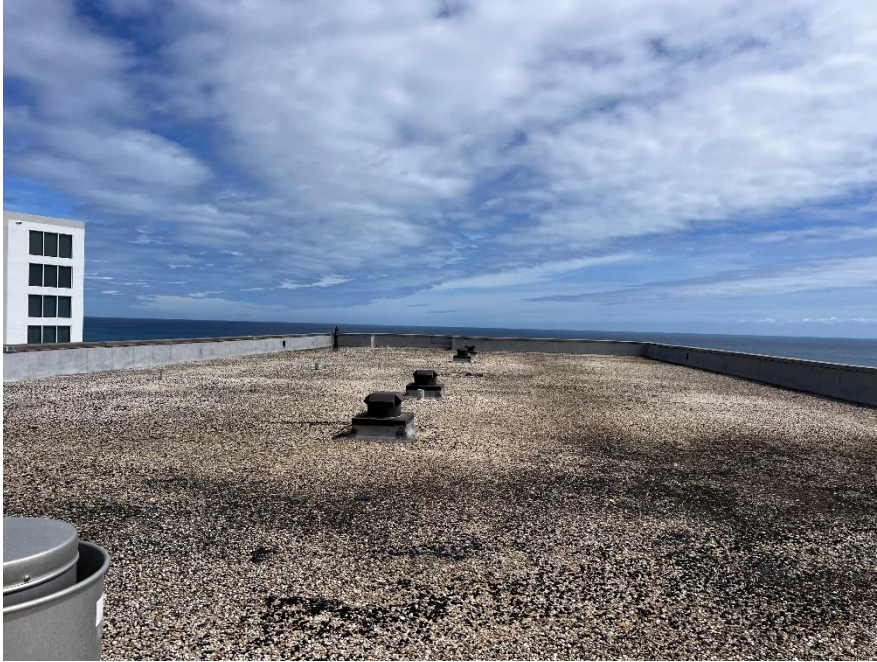
Photo #5:

Built-up asphalt roof with ballast. Some spots showed that were worn off.

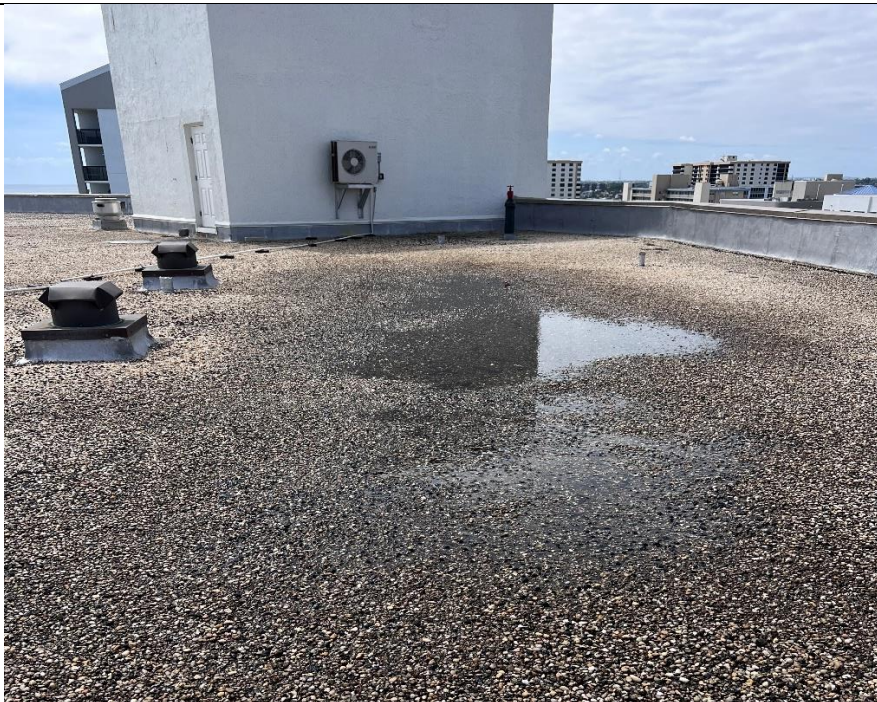
Photo #6:

The roof at Penthouse Towers Condominiums is comprised of a ballasted modified bitumen roof. We observed areas of ponding throughout the roof as well as areas of peeling paint on the soffit of the top floor catwalks and balconies. These are signs of water infiltration and deterioration of the roof membrane. We recommend that the association plan to replace the roof with a new roofing system in the next 5-7 years. If leaks become common, or roof repairs frequent, the association may desire to replace the roof sooner than 5 years.

Water ponding on the roof.

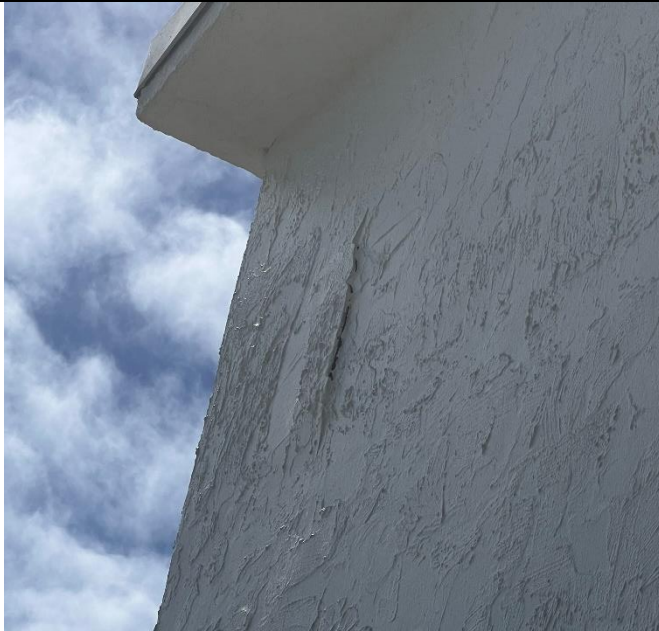
Photo #7:

Debonded stucco at stair tower on the roof.

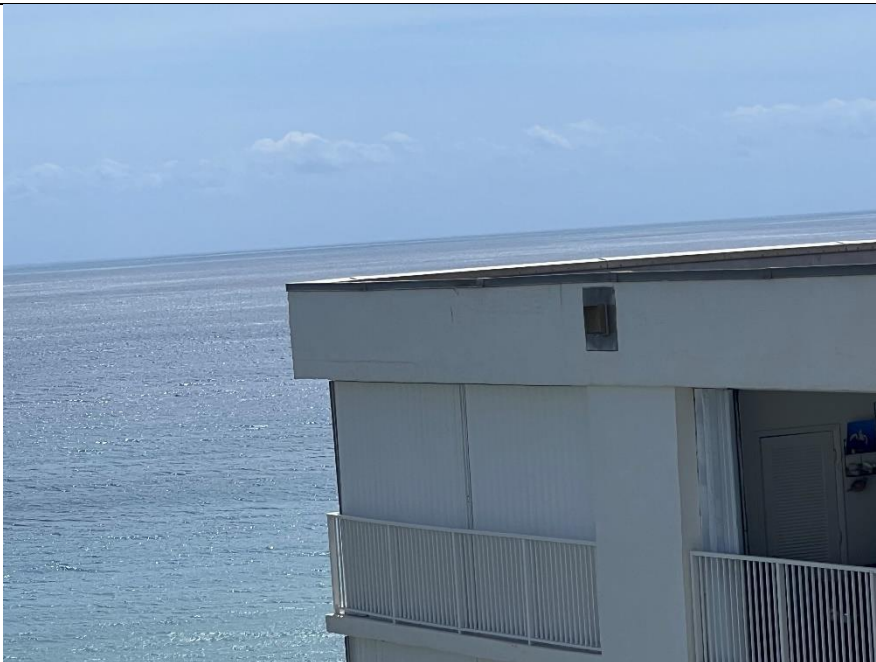
Photo #8:

Horizontal Cracks at parapet wall.

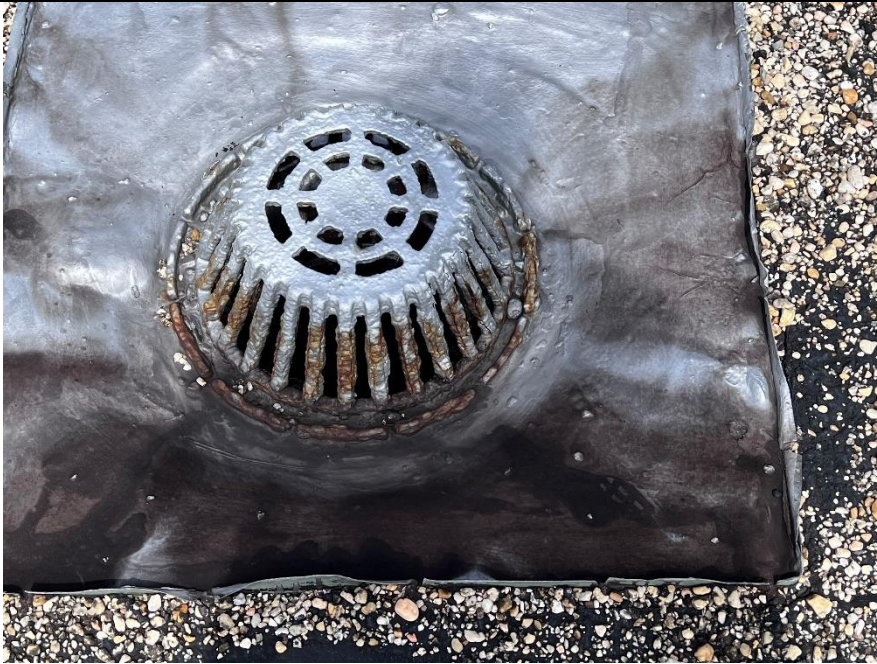
Photo #9:

Drainage in poor condition.

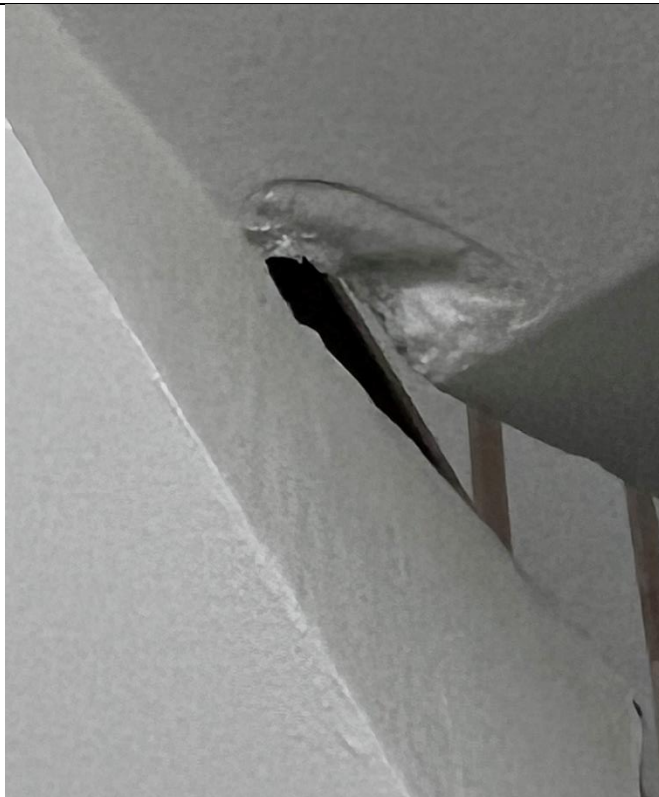
Photo #10:

Spall concrete at staircase.

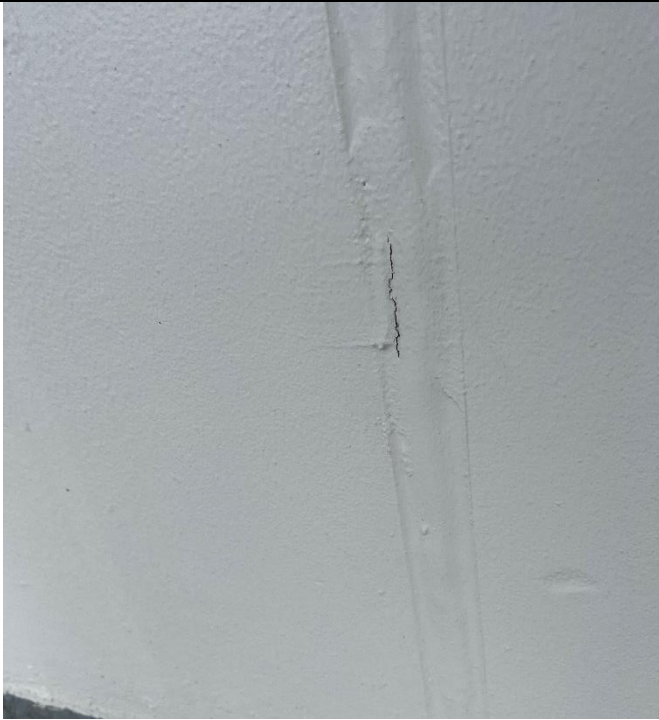
Photo #11:

The condominium forms a "C" shape with an expansion joint joining the three structures. Each floor has a vertical joint on its north and south elevations. In addition, in both the north and south elevations of the building, a vertical expansion joint follows the building's height. As we observed, the vertical expansion joints have expired and need to be replaced.

Expansion Joint has cracked and failing.

The expansion joint on the building is a critical part of the building's waterproofing element. Additionally, it is necessary when there is a transition between two surfaces to transfer movement and reduce stress. Expansion joint glands should be replaced to maintain the waterproofing envelope of the building.

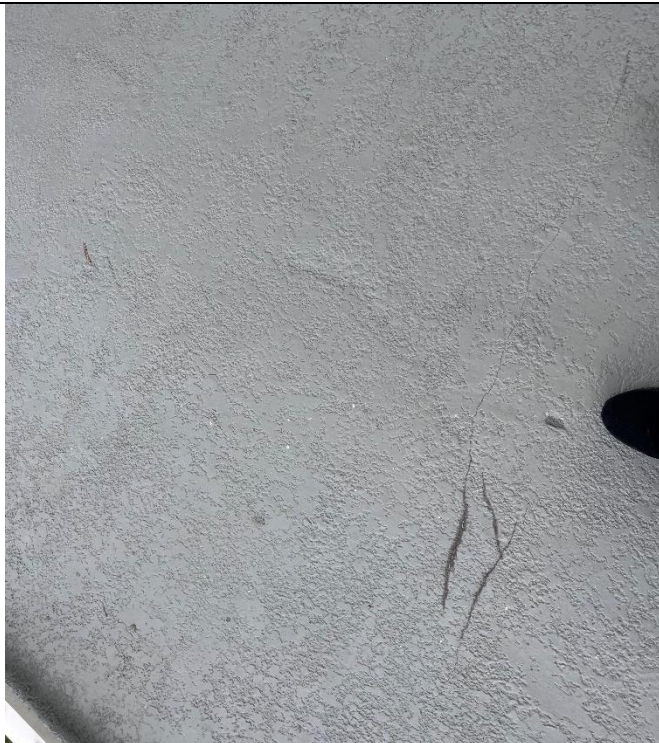
Photo #12:

We observed unsound areas and concrete cracks on the catwalk slab throughout the building. The observed deterioration is likely due to water sitting on the catwalk slab or that it was not properly repaired before the catwalk was waterproofed. We recommend that the damaged stucco/concrete be carefully removed by a contractor experienced with slab restoration and repaired per industry standards.

Concrete crack at catwalk.

We recommend the waterproofing membrane be maintained, as this will prevent water from penetrating the slab and will extend the useful life of the catwalk. The waterproofing will not eliminate corrosion that has already happened. Stopping the water from accessing the reinforcing steel will slow down or stop the rate of corrosion going forward. The waterproofing membrane has an expected useful life so the association should plan to maintain the waterproofing membrane approximately every seven to ten years.

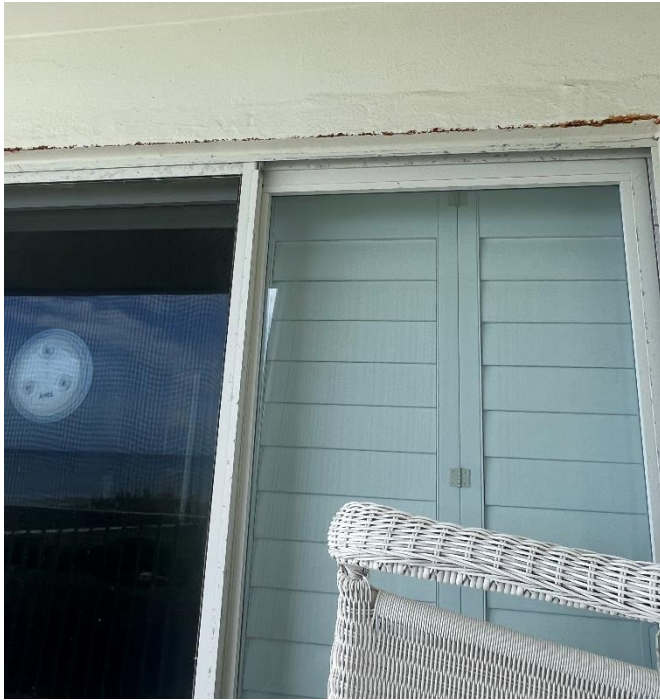
Photo #13:

Deteriorated stucco at head of sliding door

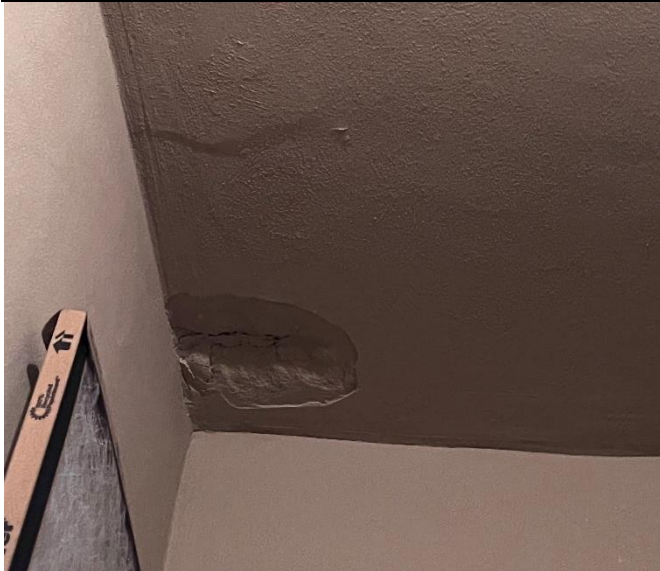
Photo #14:

Spalled overhead concrete

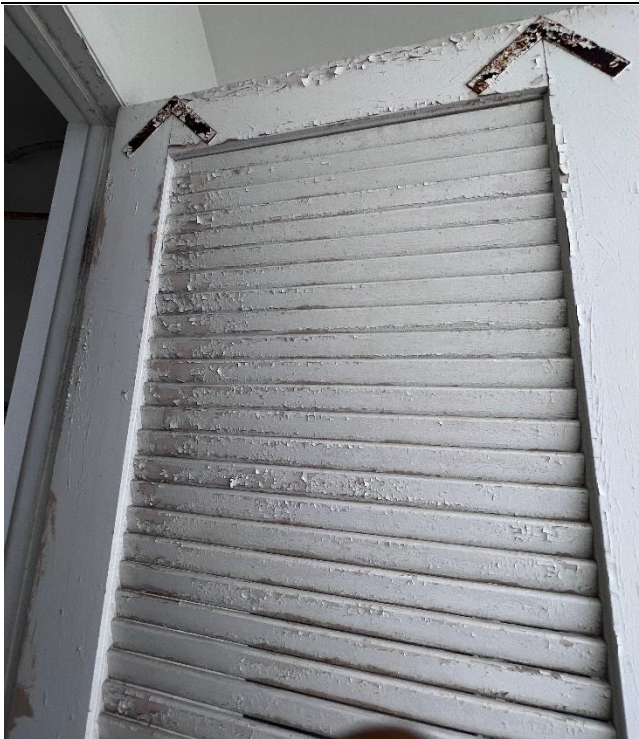
Photo #15:

Closet room door located at balconies are in bad condition.

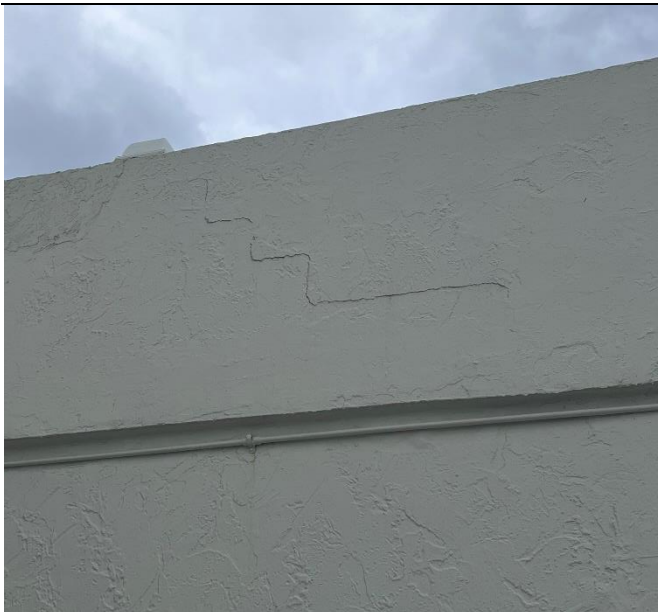
Photo #16:

Step crack at parapet wall

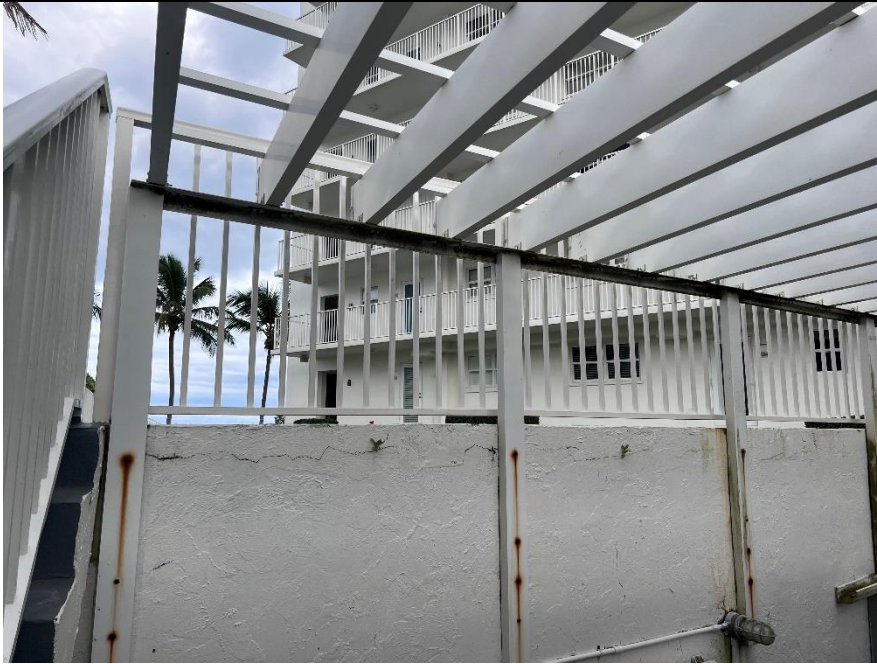
Photo #17:

We observed horizontal cracks, step cracks, and debonded concrete on the north elevation of the cooling tower, as well as on the staircase during our walkthrough of the building. By hammer tapping and observing the horizontal cracks, we found that they were in unsound conditions. It is possible that the cracks, and debonding were caused by water intrusion, shrinkage and expansion caused by heat exposure to the concrete. Another possible effect may be caused by exposure to salt in the sea air. In order to properly repair the retaining wall, the rails need to be removed. An experienced contractor should be hired to perform this task to facilitate better access. In addition to repairing existing concrete, all surfaces should also be painted and coated after all repairs have been made.

Cooling tower at north elevation has horizontal and concrete step crack.

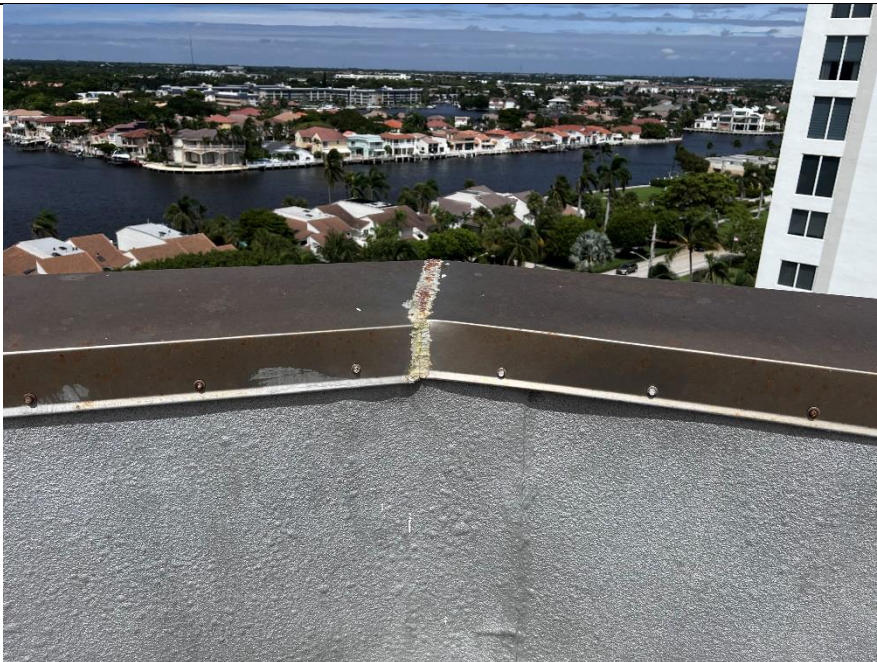
Photo #18:

The roofing system at Penthouse Towers includes metal coping over top of the parapet walls. We observed that the joints in the metal coping have expired. The joints should be watertight for the coping to perform as originally designed. We recommend that the joints be waterproofed immediately with silicone based sealant, and that the association include replacement of the metal coping as part of the roof replacement.

Metal capping at the parapet wall not properly covered.
